Building Envelope News

Condo uses foam in air barrier and fire stop combo

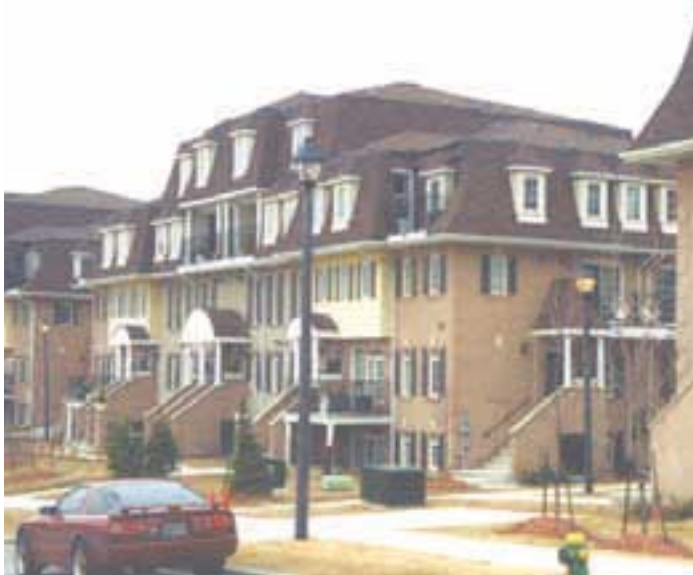
Two-component polyurethane foam was specified by architect Alex Talwood to prevent the migration of exhaust fumes from the underground parking into the units of this Toronto condominium complex.

He wanted to prevent air migration through 600 vertical penetrations for water, gas, power, telephone and cable television. These pathways are usually stuffed with fibrous material and mortar, which slows the transfer of heat, flame and smoke. He also felt that standard fire-stopping procedures would not be sufficient and therefore specified polyurethane foam as part of the fume and fire stopping package.

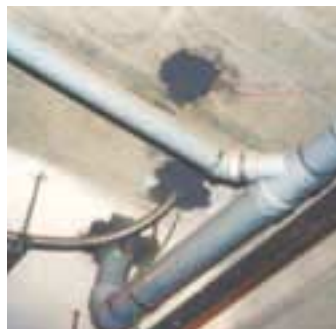
Foam was injected into the vertical pathways to ensure a 100 per cent air seal.

The Canam team injected two-component polyurethane foam into the vertical pathways to ensure a 100 per cent air seal. Foam, in combination with mortar, performs

better as a fire-stop, and also stops stack effect and the migration of the fumes from the parking lot.

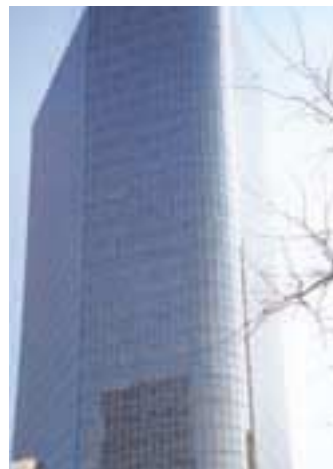
Prior to work done by Canam, fluctuations in temperature were a source of concern for tenants of this Toronto high-rise.

To confirm their diagnosis, a swing stage was brought in, and several mullion caps were removed. It was at this point that they discovered the silicone caulk used at the vertical and horizontal junctions in the original construction of the building had failed.

"Most buildings are built to allow for some movement, so it's imperative that a suitable seal – one that can bend and stretch – is used," says Mark Brook. "In this case it wasn't a building error; the material just failed."

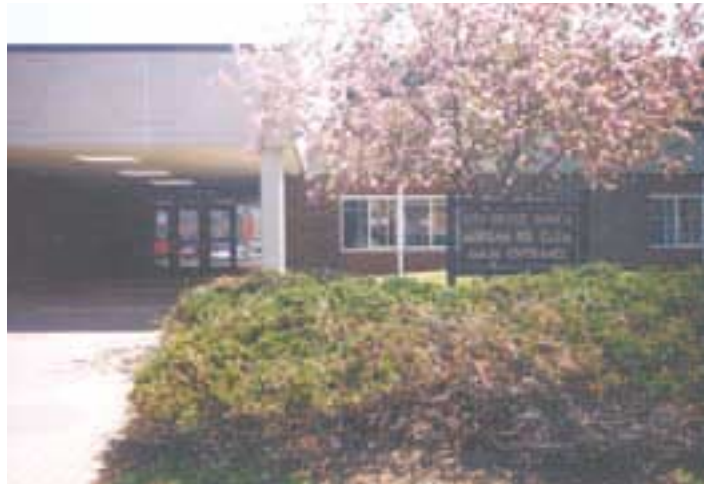
Building envelope repairs performed for the Liverpool Central School District in Metropolitan Syracuse have received positive feedback from teachers and students, as well as other employees.

Feedback from teachers, students and other Liverpool employees has been very positive, according to Kaczynski. Particularly from employees at the Bus Maintenance Garage and Transportation Center who have reported a clear improvement in interior comfort levels and working conditions for garage employees thanks to a significant reduction in drafts, frost and icing around the large overhead doors.

"Upgrading weather stripping on the doors and windows was a large part of the project," says David Kaczynski. "The old weather stripping on the door frames was all exposed where the kids come in and out – and where they can grab it, swing from it, kick it and generally just be kids. It caused a lot of wear and tear."

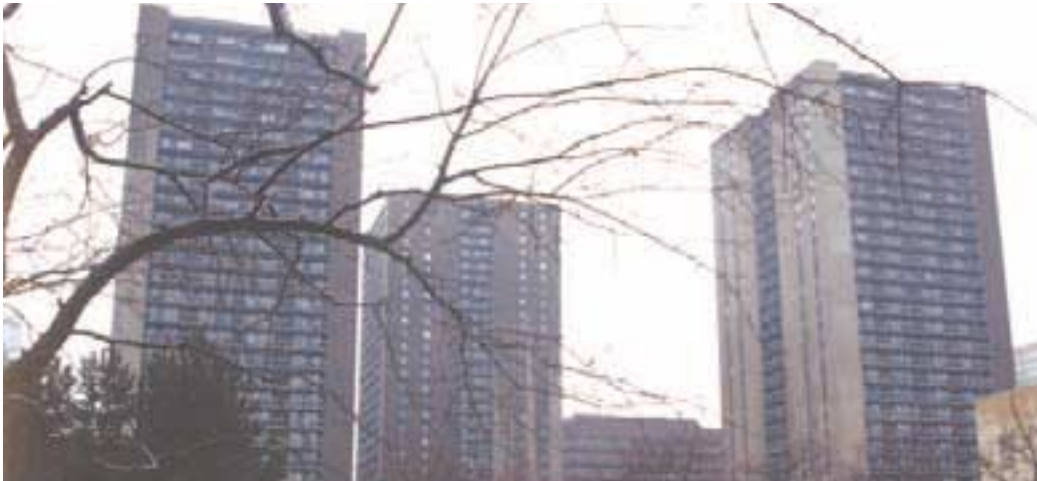
Solving stack effect addressed comfort problems for residents of Forest Laneway and helped save the owners over \$200,000 a year in energy bills.

Stack effect in these buildings was found to be extreme and it was causing comfort problems, particularly with lower units. Canam informed the building owners that controlling stack pressures would improve comfort, energy efficiency and odour control."

At the bottom of the building, the team effectively sealed the many penetrations found in the underground parking areas. Doors were weatherstripped and a large number of unsealed cable conduit duct and pipe penetrations and gaps

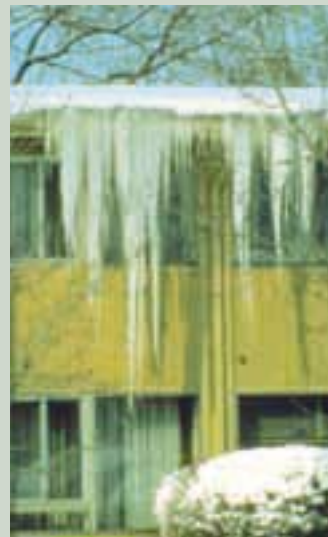
Ice damming can not only ruin a roof; icicles like these can be dangerous if they break off and fall.

Ice-damming occurs when melting snow on the roof refreezes at roof edges and forms dams. These cause further melting snow to back up under shingles and enter the attic where it leads to moisture damage to ceilings and walls.

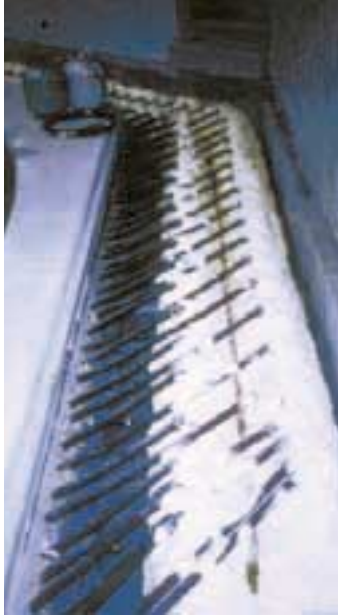
Insulating brine headers with foam prevents condensation on the surface, reducing corrosion, icing and frost heave.

Brine headers are the tubes that feed the refrigerant to maintain the ice surface, usually steel pipe construction, run in a trench from the mechanical room. As the temperature of the fluid is around -7°C (or 20°F), the headers will "sweat" and moisture will freeze on the pipes.

Insulating with foam provides a moisture tight "cocoon" that encapsulates the lines and prevents moisture forming on the surface. Benefits include: reduced energy and maintenance costs, return on investment achieved in two to three years and increased safety to patrons. The insulation will last the life of the system and implementation is fast and straightforward. Insulation out-performs the traditional stop-gap methods of replacement and repainting, is environmentally friendly and equally effective for both new construction and retrofit projects.
